Building Inspection Report

123 Any street , IL

Inspection Date:
2/23/2009

Report Number:
mk00209

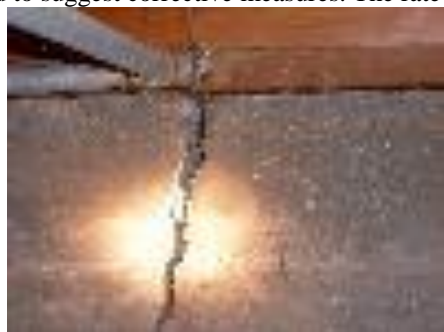
- **Major Concern:** Substantial foundation settlement cracking was observed. Structural movement of the building has occurred. Since repairs are needed to protect the building from more serious damage, a structural engineer who is familiar with foundation repair or a company specializing in foundation repairs should be consulted to evaluate the condition and to suggest corrective measures. The rate of movement cannot be predicted during a one-time inspection.

Monitor foundation crack

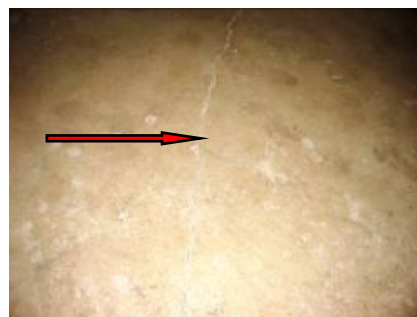
Crack in basement slab

Cracked concrete floor slabs, although not structural components of the house, can be replaced if desired. Replacing a slab is a significant cost.

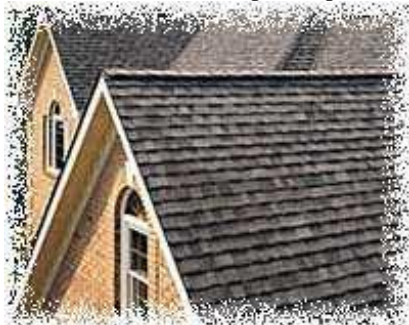
Roofing in good shape

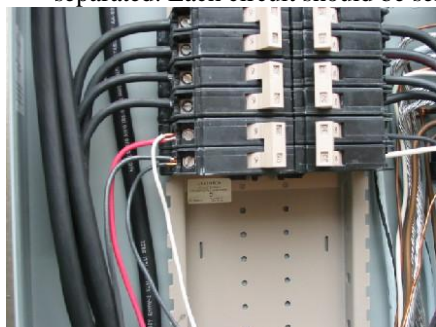
- **Repair:** Circuits within the main distribution panel that are doubled up (referred to as "double taps") should be separated. Each circuit should be served by a separate fuse or breaker.

Double tapping

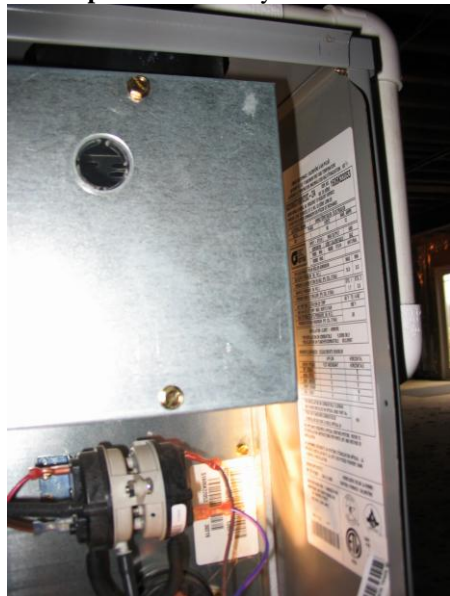
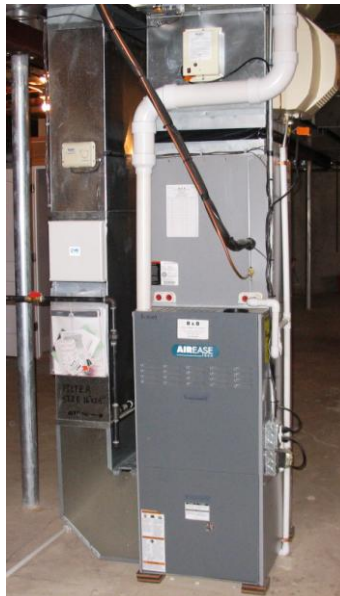
- **Improve:** The dirty air filter should be replaced.
